Site Assessment report

52 Pablo Road, Woop Woop

Date of report 12 December 2019

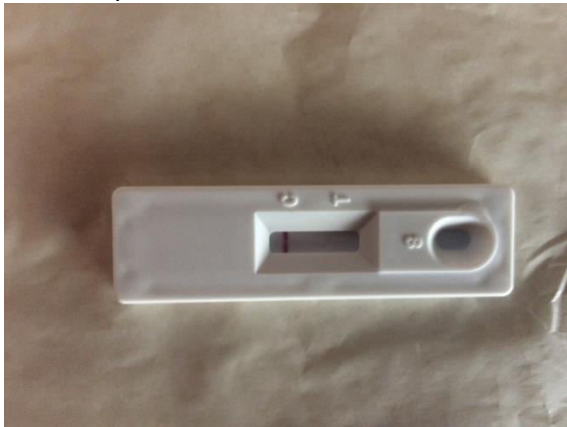
At 10:30am on 5 December 2019, I attended the property where I collected an initial MethChek 500 from the kitchen ceiling which returned a positive result to methamphetamine residue.

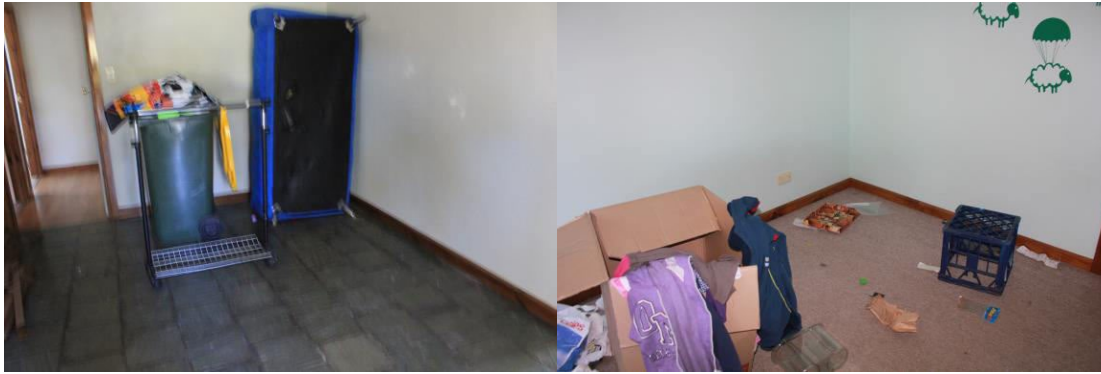
On first appearance the property was in a vacant state. Not unduly messy with some items left behind after the tenants had moved out as per the following pictures.

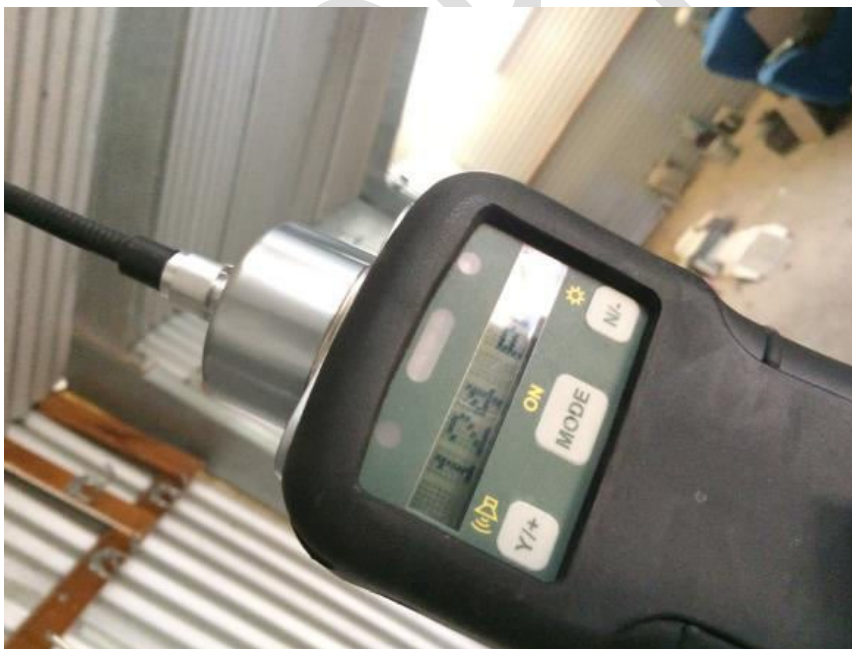
VOC levels were taken throughout the property all returned acceptable levels. The garage ranging from 124ppb to 1833ppb in the cut out in the slab.

In the corner of the garage was a cut out in the concrete slab that contained an unidentified liquid.

VOC testing of this liquid returned a level of 1833 PPB not what I would call extremely high. In original photos supplied there was appeared to be an alcohol distiller. It is quite possible that the liquid is in fact dregs from a distilling process, although this cannot be confirmed.

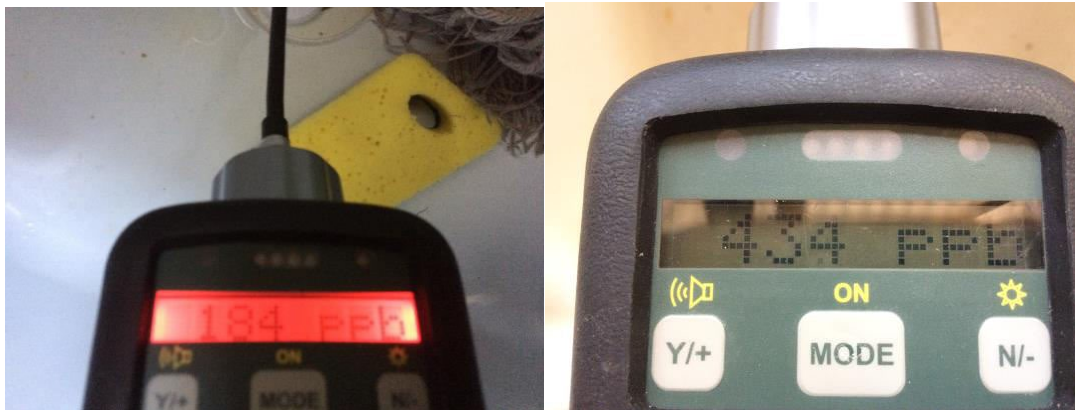
The house ranging from 184ppb to 434ppb
